DEPARTMENT OF NATURAL RESOURCES
DIVISION OF OIL, GAS AND MINING

RE: Site Inspection; Advanced Mineral Technologies, LC; Ursa Major Project; S/055/071;
Wayne County, Utah

Date of Inspection: December 13, 2002
Time of Inspection: 11:15-11:45 a.m.
Conditions: Cloudy, 30's
Participants: Paul Baker, DOGM

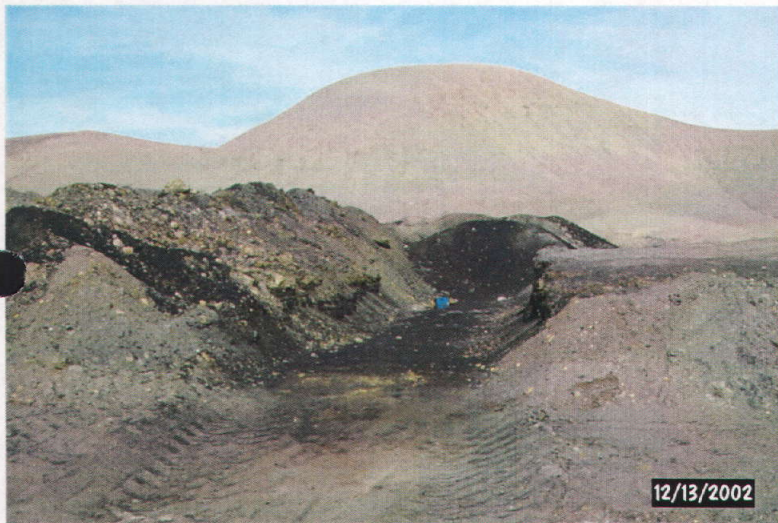
The disturbance is relatively small, less than ¼ acre not including the road. The road that leads north to the site should probably be considered part of the disturbance although the larger road that basically parallels SR 24 appears to be pre-existing. The mine includes a trench about forty feet long, six feet wide and three feet deep (Photo 1), and there is another small excavation (Photo 2). There is no vegetation in the mine area or on the adjacent hills. There was a little trash.

Photo 1. Trench about 40 feet long, 6 feet wide, and 3 feet deep.

The operator should ensure that the trash is cleaned up and should try to keep excavated materials out of the drainage. This is not a serious problem.

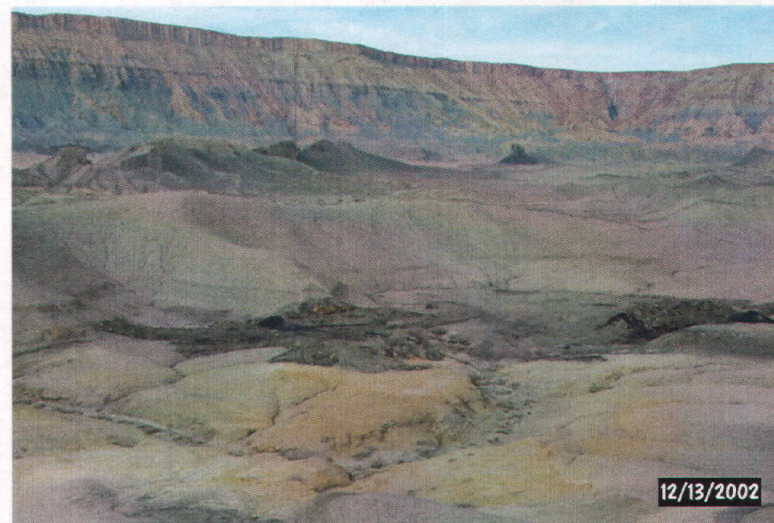
Photo 3. Overall view of the area from an adjacent hill.
